# Evaluation Report 153

## Leon CP77-334 (10.4 m) Chisel Plow

## LEON CP77-334 CHISEL PLOW

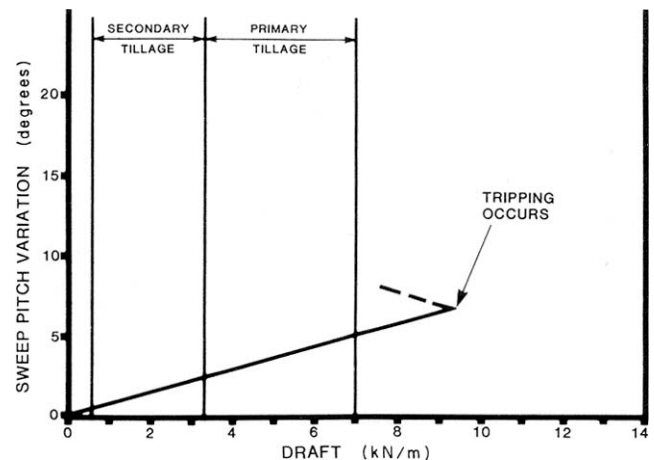
FIGURE 3 shows pitch characteristics of the Leon CP77-334 shank assembly. The low end of the pitch curve results from shank flexing. Sweep pitch varied about 5 degrees over the full range of draft normally occurring in primary tillage. When equipped with 51 degree sweeps, as used during the test, sweep pitch varied from minus 5 to 0 degrees over this draft range. At the manufacturer's setting, the shank trips began to release and shank force decreased at drafts greater than 9.3 kN/m, as shown on the graph. Tripping occurred well beyond the normal draft range, indicating that the Leon CP77-334 was well suited for heavy primary tillage.

FIGURE 3. Sweep Pitch Variation over a Normal Range of Draft (305 mm shank spacing).

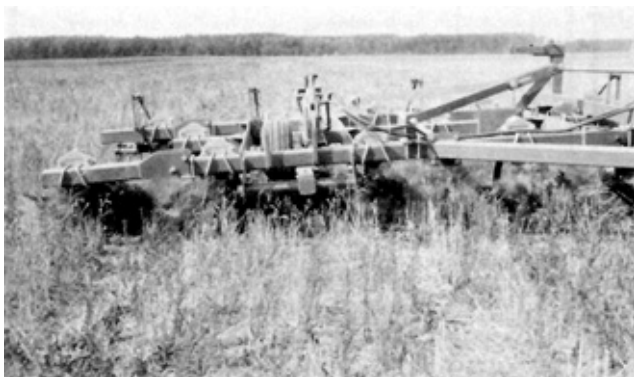
Depth differences between the front and rear rows of shanks were slight in normal soil conditions, once the frame had been properly levelled. In heavy primary tillage, twisting of the wing frames caused the outer front sweeps to penetrate about 60 mm deeper than the outer rear sweeps.

FIGURE 5. Excessive Wing Penetration in Heavy Primary Tillage.

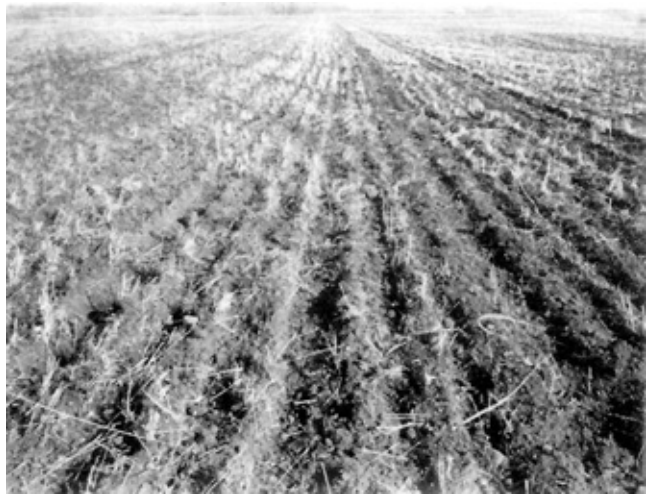
Trash burial with chisel points (FIGURE 6) in heavy crop residue was good. The action of the chisel points moved enough soil for adequate trash burial while leaving some standing stubble for snow retention.

FIGURE 6. Typical Trash Burial with Chisel Points.

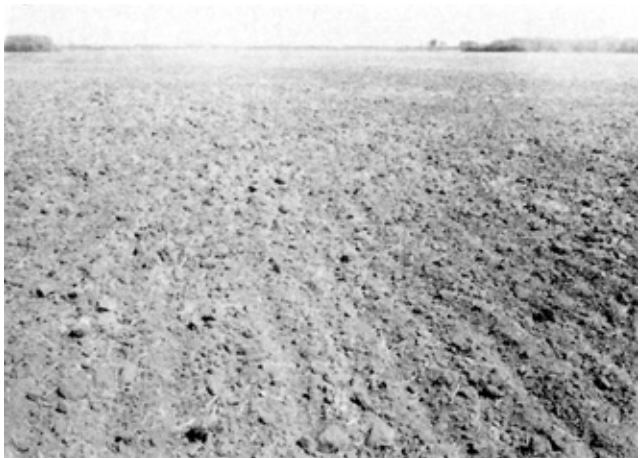
Surface ridging varied from 25 to 50 mm. The optional mounted harrows were effective in smoothing these ridges (FIGURE 7).

FIGURE 7. Typical Field Surface when using Optional Mounted Harrows.

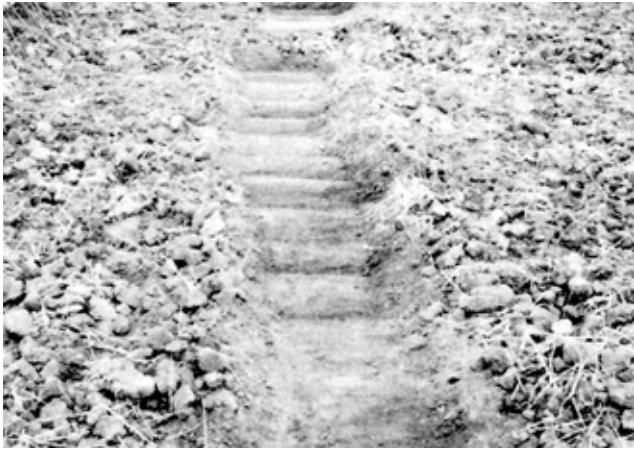
**Furrow Bottom Ridging:** In normal soil conditions, furrow bottom ridging was caused by the sweep nose curvature and was less than 15 mm (FIGURE 8). Greater furrow bottom ridging occurred in hard soils, especially at the wing ends due to wing frame twisting.

FIGURE 8. Typical Furrow Bottom.

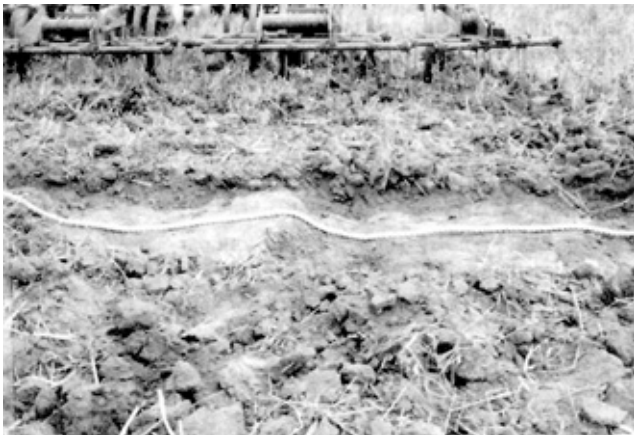
Some sweeps were not held level because of faulty shank holders. This resulted in random furrow bottom ridging (FIGURE 9). This problem was corrected after the faulty shank holders were shimmed or replaced.

FIGURE 9. Furrow Bottom Ridging caused by Faulty Shank Holders.

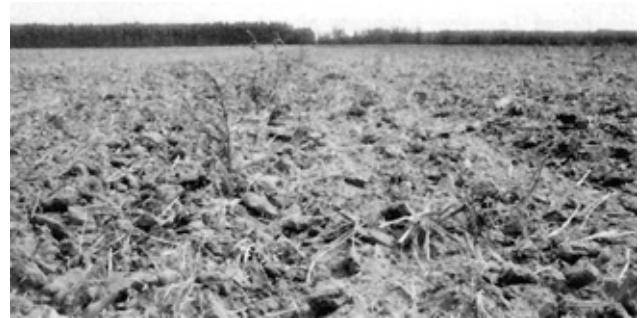
**Skewing and Stability:** The Leon CP77-334 was quite unstable. It skewed significantly on side slopes and in heavy draft conditions when encountering soil that varied in hardness across the machine width, resulting in weed misses. The sweep pattern (FIGURE 10) however was symmetrical and did not pose any resultant side forces on the cultivator during normal tillage. The shanks adjacent to depth control wheels were fitted with 356 mm sweeps to prevent tire interference. The minimum skew angle for weed misses between these sweeps and the adjacent 406 mm sweeps was 2.4 degrees. At several other locations shanks could not be spaced at 305 mm, due to interference of shank holders with the frame, resulting in weed misses at similar skew angles.

FIGURE 11. Weed Misses Caused by Skewing.
